**Appendix C-4**  
**Accident Studies**

## Accident Summaries for I-81

## **I-81 Viaduct Project – Syracuse, New York**

### **Non-Standard and Non-Conforming Features Evaluation S-Curve and Slalom Area**

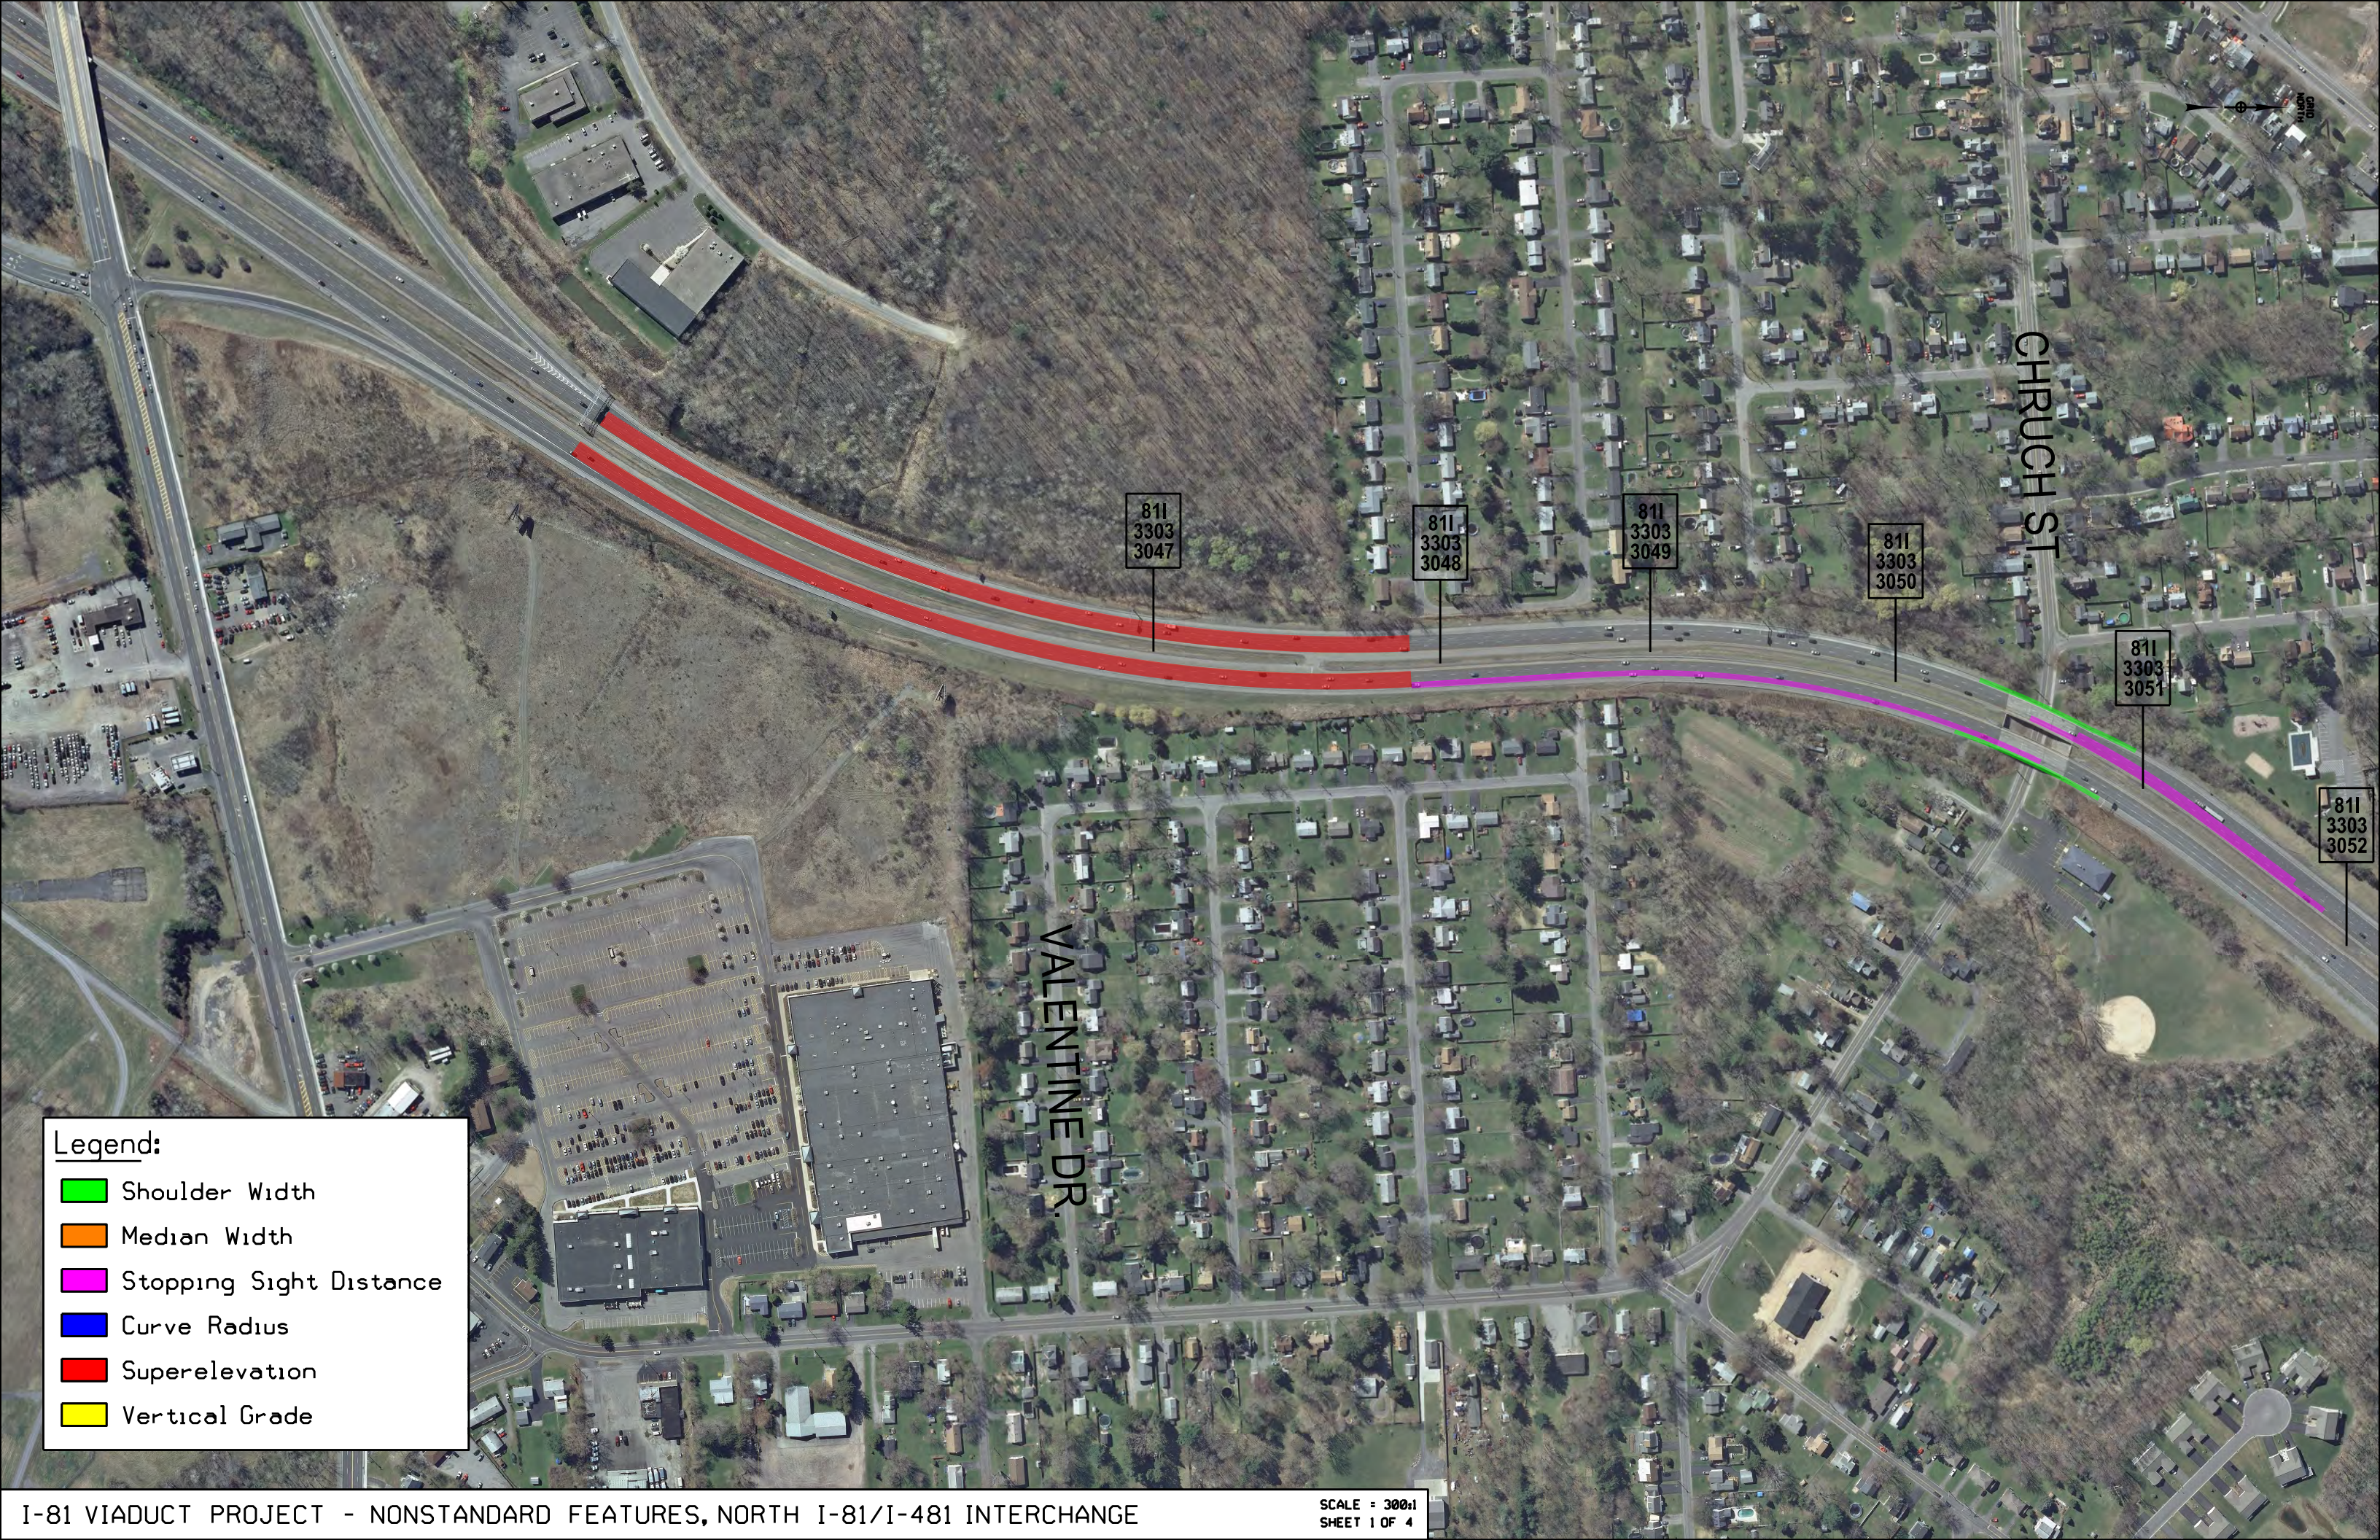
**Figure 3**

**I-81 Viaduct Project – Non-Standard Features**

Numerous non-standard features (i.e., shoulder widths, median widths, vertical grades, superelevations, curve radii, and stopping sight distances) and non-conforming features (i.e., sub-standard acceleration and deceleration lengths and ramp-to-ramp spacings) were identified in the I-81 Viaduct project area. The locations of the non-standard/non-conforming features were detailed in a previous planning study and were spot-checked in the field for this project. There are no non-conforming features in the north interchange area. However, as shown in Figure 3, there are various non-standard features – the most common of which is non-standard superelevation on the area roadways, including some ramps. It should be noted, however, that significant portions of the study area north and east of the interchange do not have any non-standard features and were not identified to have high accident numbers. For this reason, further

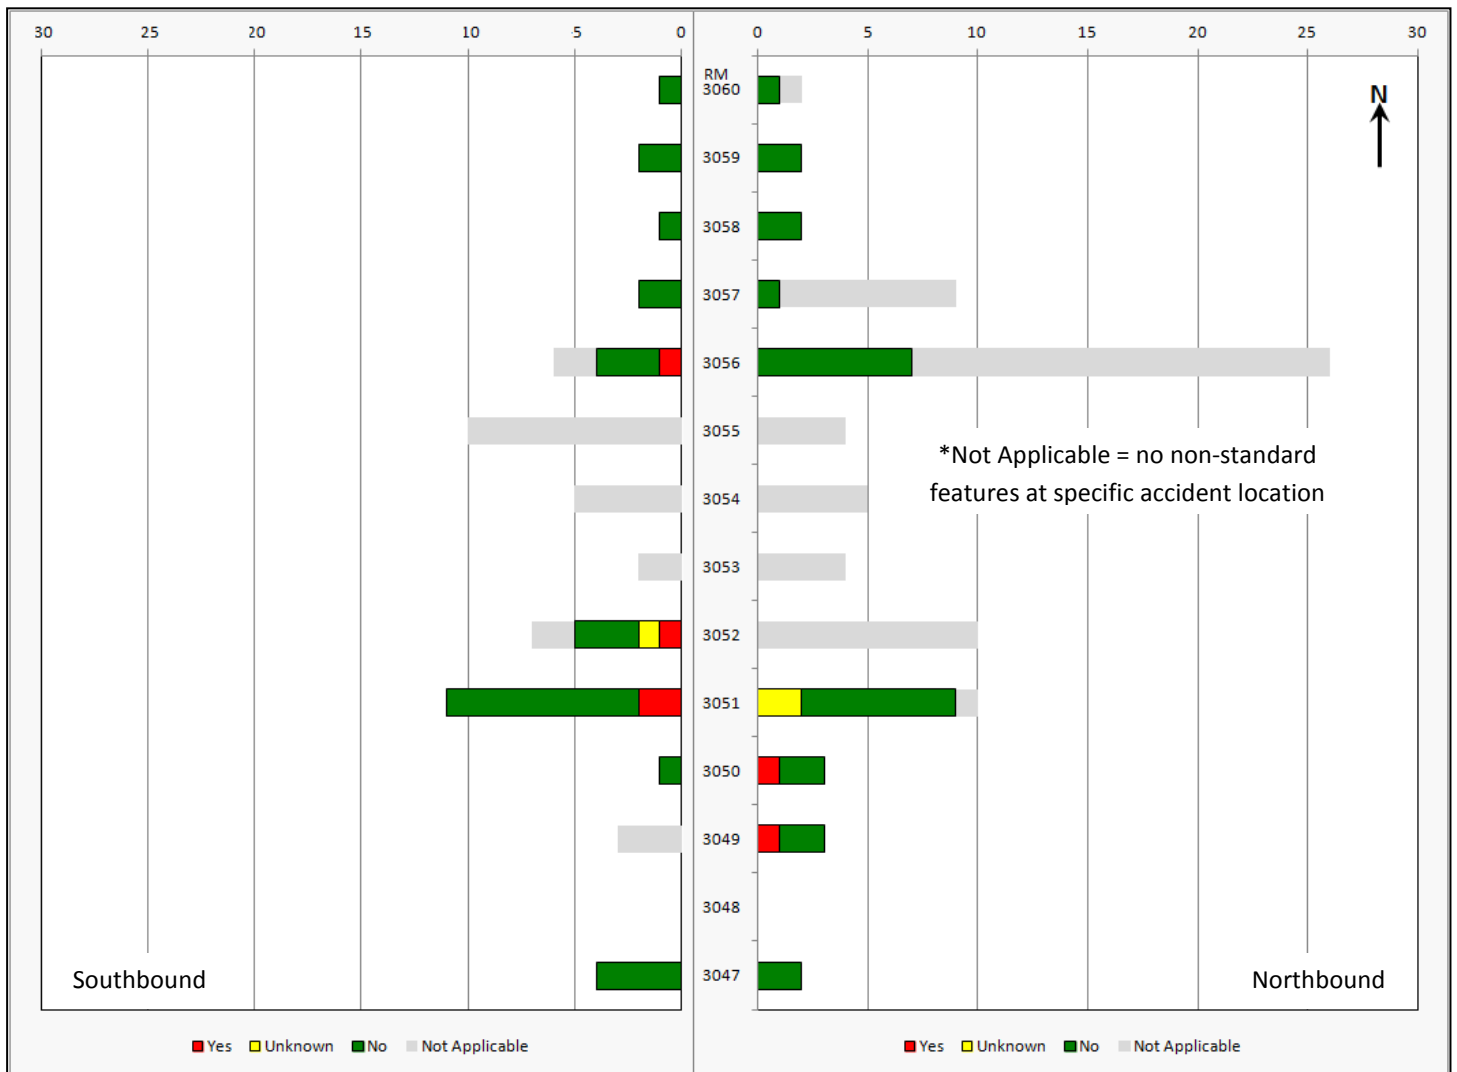
**Figure 4 – Correlation of Total Number of Accidents for 3-Year Period to Non-Standard Features by I-81 Reference Marker**

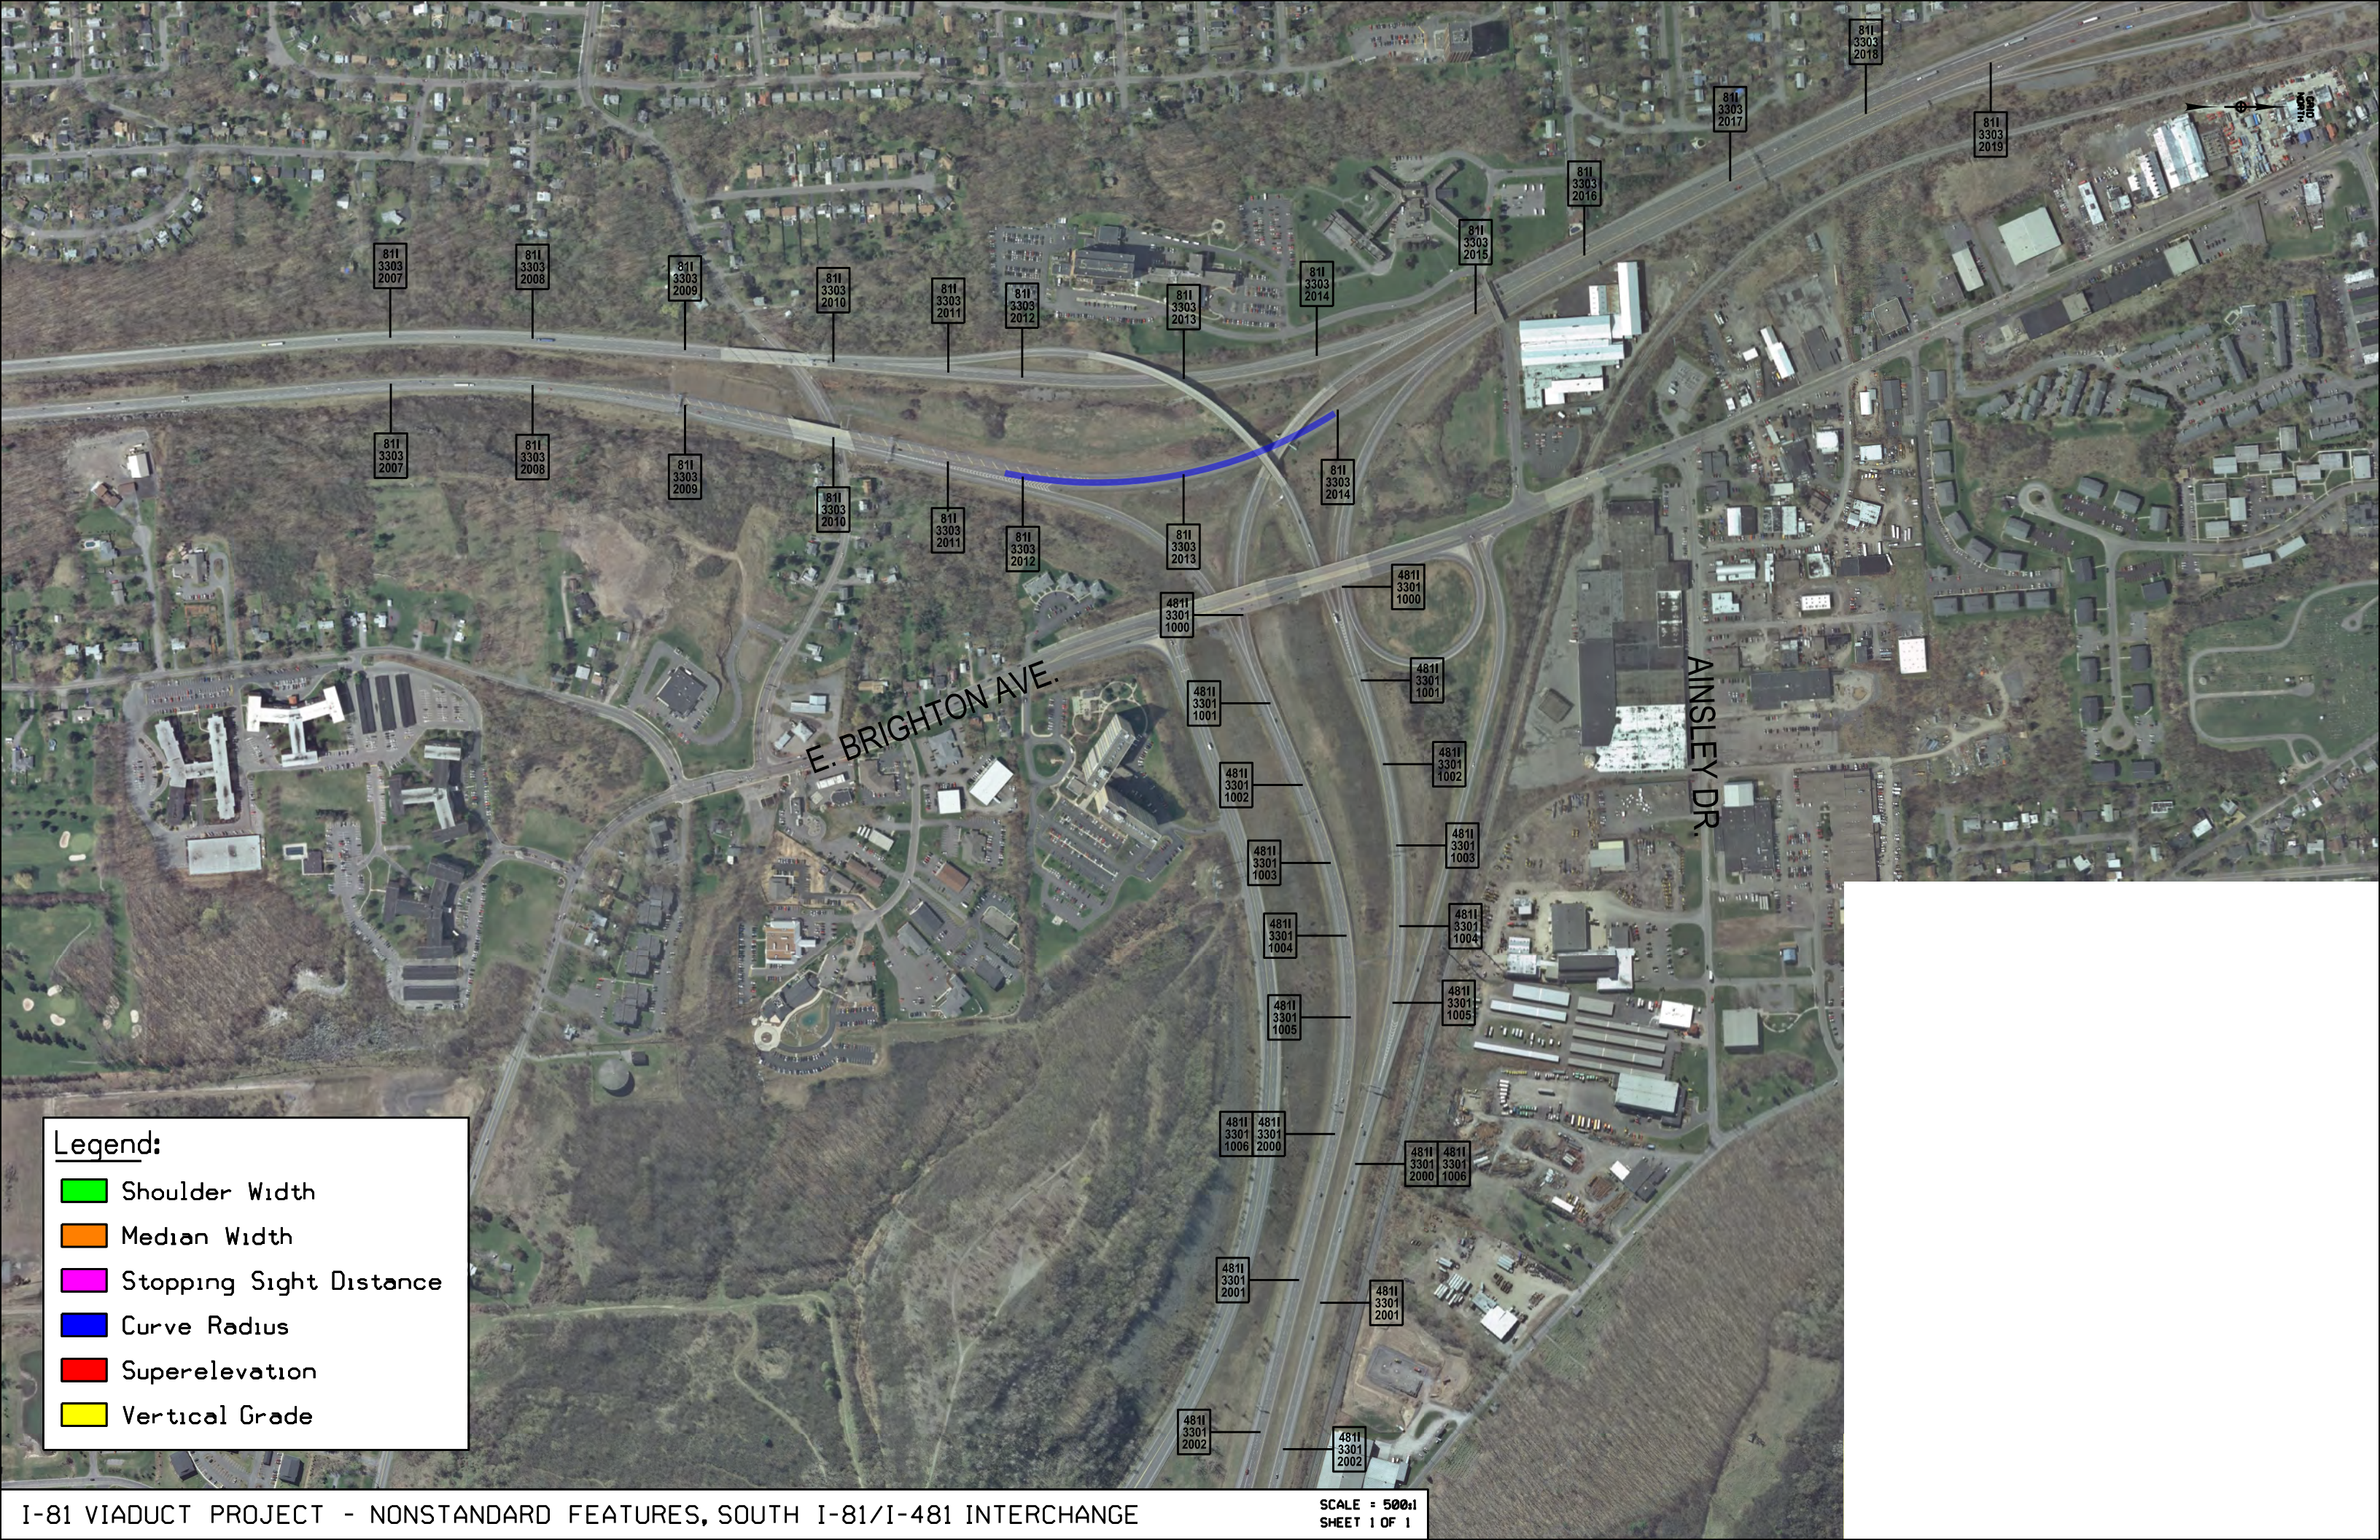
**Figure 3**

**I-81 Viaduct Project – Non-Standard Features**

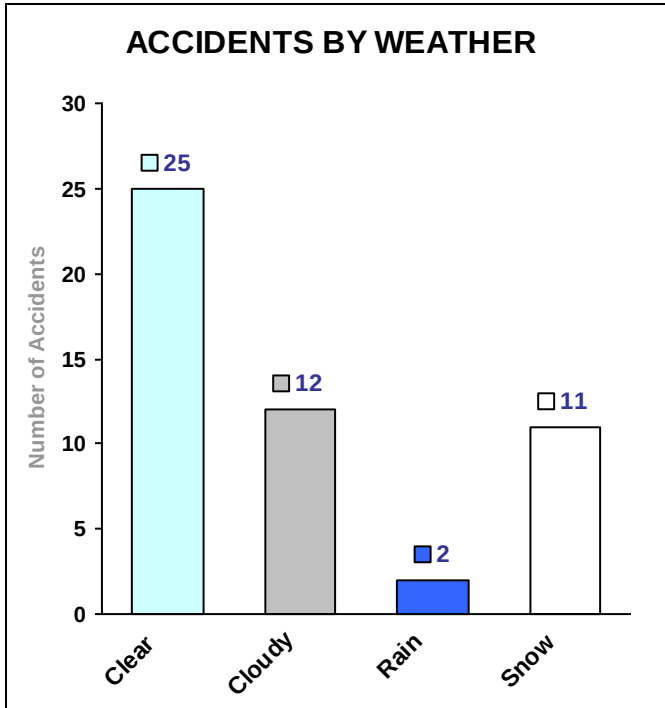
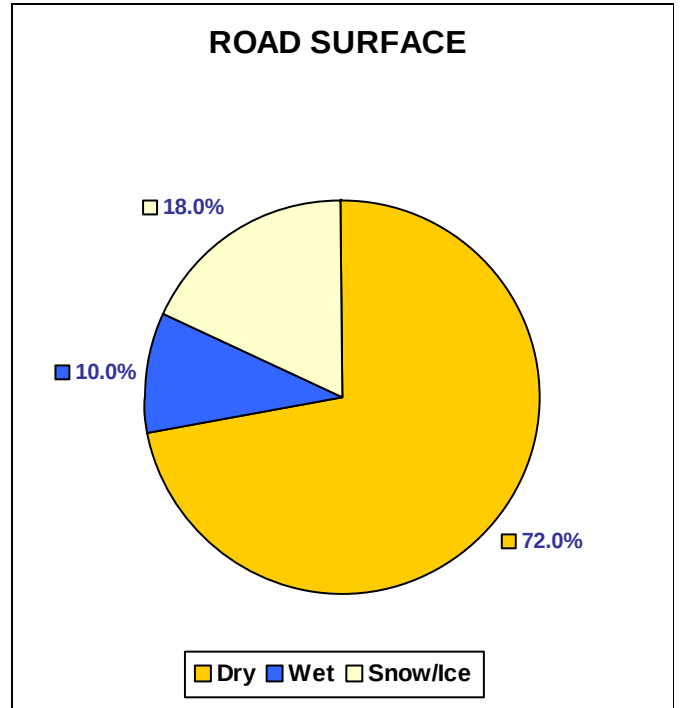
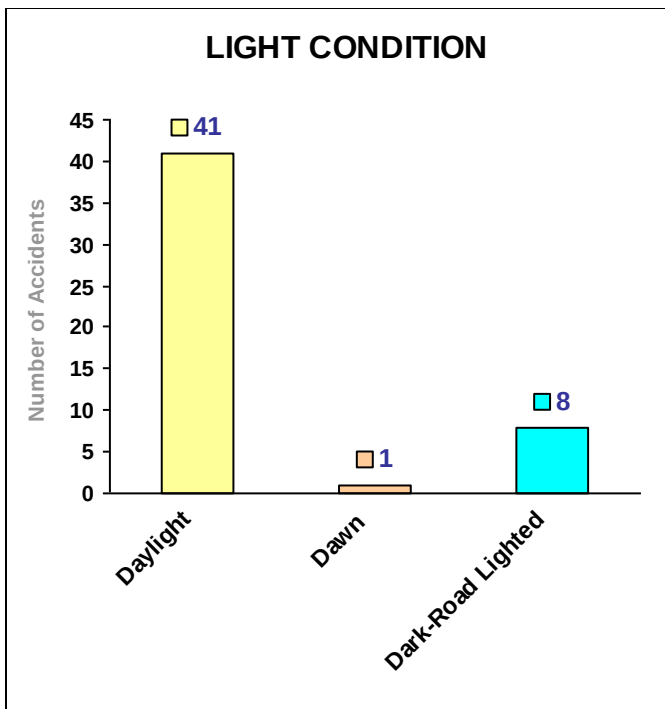
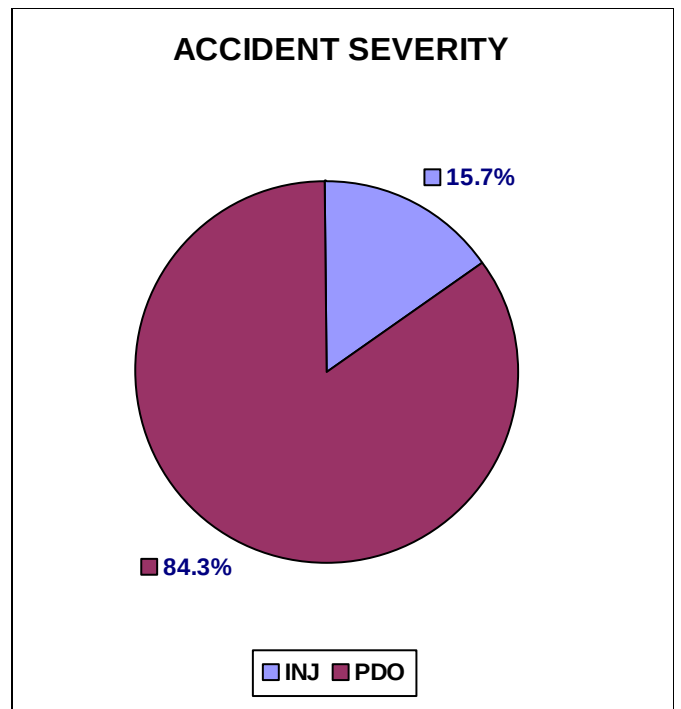
# HSA CHARTS

ROUTE: 81/ LOCATION: Syracuse, New York  
 TIME PERIOD COVERED: 7/1/2010 - 6/30/2013 REFERENCE MARKERS / NODES 81/ 3303 2006 - 81/ 3303 3066  
 REMARKS: SB Accidents at Court Street Weave - RM 2060 to RM 2056 DATE: 3/10/2015
