HAZARDOUS WASTE/CONTAMINATED MATERIALS  
SCREENING ASSESSMENT REPORT

I-81 VIADUCT PROJECT  
SYRACUSE, ONONDAGA COUNTY  
PIN 3501.60

OCTOBER 2016

**WATTS**  
ARCHITECTURE &  
ENGINEERING

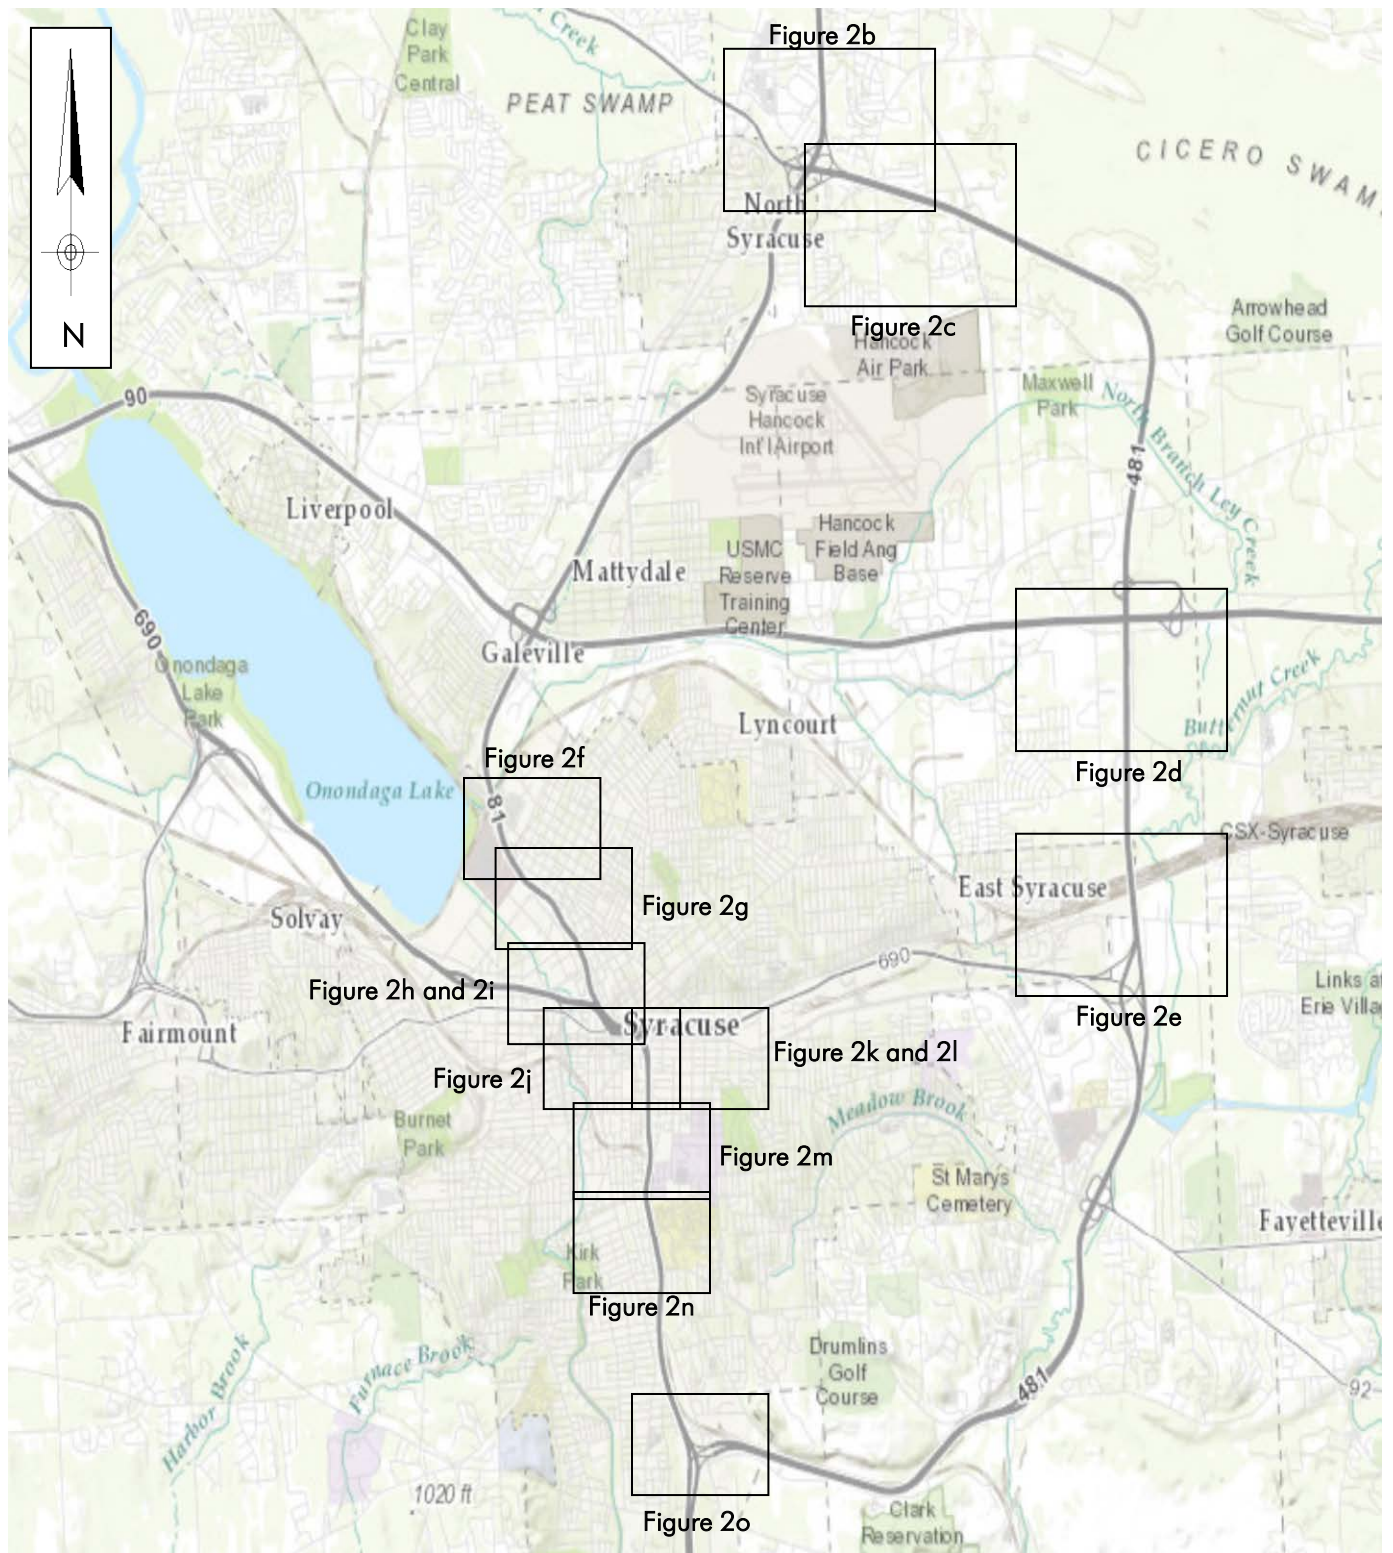
Figure 2a: Sites of Potential Environmental  
Concern Overview Map

The following properties are considered to be potential environmental concerns with respect to the Project Area. The Project Area and the location of each property of potential environmental concern to the proposed project are shown in **Figures 2a-o (found at the end of this report)** by designated site number. Many of the sites consist of more than one parcel (based on ownership). The addresses and ownership were identified on the Syracuse Onondaga County GIS Parcel Viewer. Photographs of the sites of potential environmental concern are available by request but are not included in this report.
